# Laboratory Evaluation of Biofilm and Mineral Deposition on Concrete Surfaces

**USG Water  
Solutions**

**White Paper**

2026

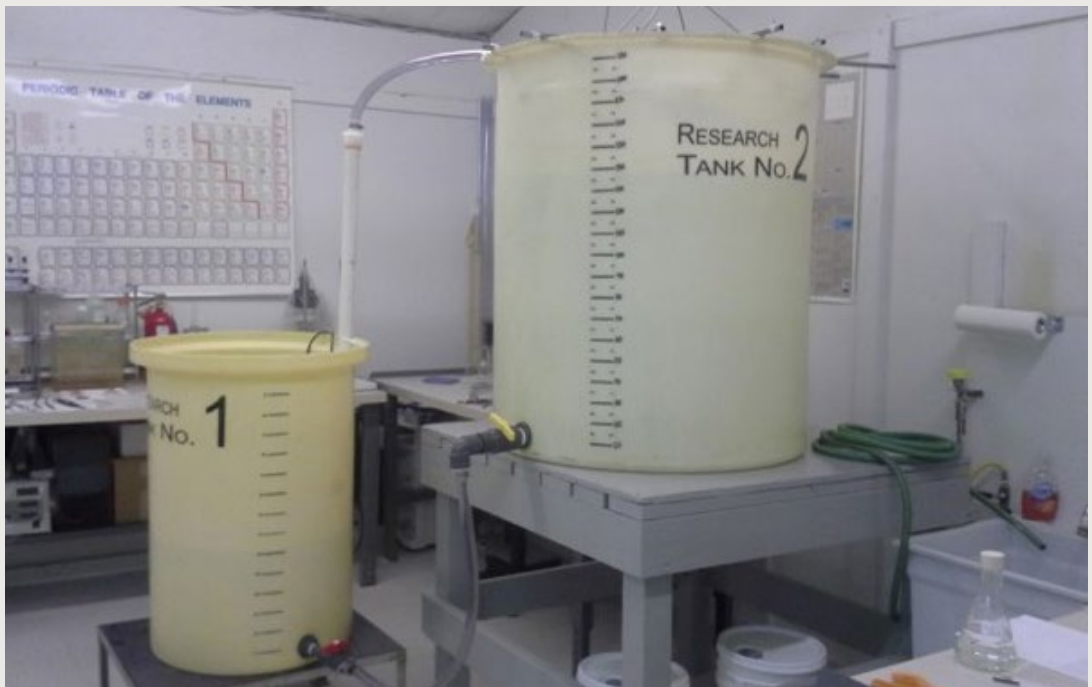
IMAGE 1

A polyethylene plastic water storage tank was fabricated and operated using a municipal potable water source under ambient climate conditions<sup>1</sup>. The primary observation tank, a 200 gallon poly tank, measures 45.5" tall by 36" in diameter, was left open at the top for easy access and equipped with gallon indicators and a 1.25" PVC Ball valve for adjusting water levels. Approximately 200 gallons of water were used for this study which was mixed daily to insure a homogeneous solution. Mixing was accomplished by draining the primary tank into a secondary polyethylene collection tank which was then recirculated into the primary tank with a 1/3 horsepower submersible pump.

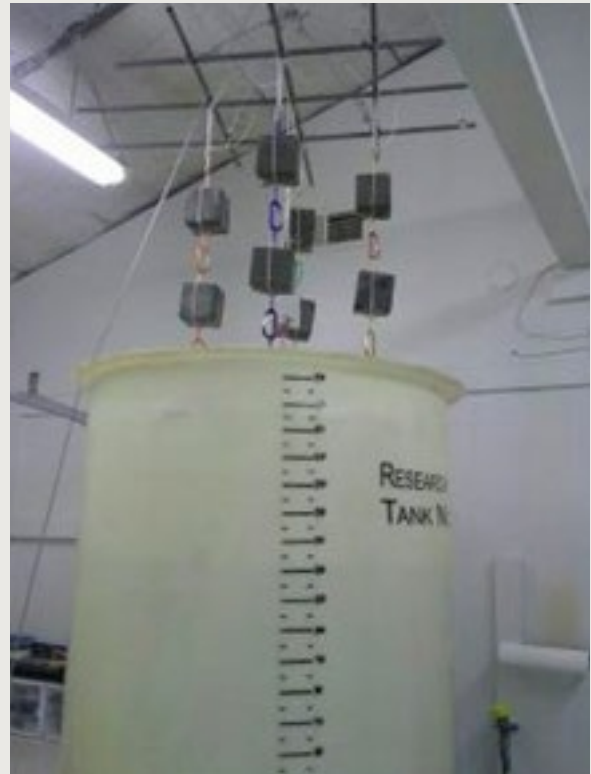
IMAGE 2

Drain and fill cycles were intended to mimic actual fluctuations in water levels encountered in operational potable water storage tanks. Concrete coupons, measuring approximately 4" x 4" x 4", were suspended from a non-reactive metal grid which could be raised and lowered manually with limited disruption for easy access to the coupons during sampling.

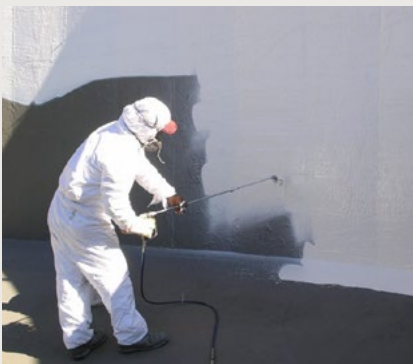
IMAGE 3: COATING APPLICATION

The coatings utilized as part of this study included Tnemec's Series 22 Epoxoline and Series N140 Pota-Pox Plus. Series 22 Epoxoline is a 100% solids, solvent-free, immersion-grade modified polyamine epoxy liner. The coating is normally applied between 20 and 40 mils Dry Film Thickness (DFT) in one or two coats using airless spray or plural-component spray equipment. Series 22 has passed stringent testing for extractables in potable water applications and is VOC compliant in all air districts. The Series 22 Epoxoline is ANSI/NSF Standard 61 certified for use in potable water storage tanks, reservoirs, pipes, and valves.

Series N140 Pota-Pox Plus is a 67% solids, solvent-based, polyamidoamine epoxy coating used for nearly two decades in potable water immersion service. Typically applied in two to three coats (maximum 17 mil DFT) by air or airless spray application, but can also be roller-applied. Low VOC and fast-cure versions of the coating are also available. The Series N140 Pota-Pox Plus is ANSI/NSF Standard 61 certified for potable water contact when used on storage tanks, reservoirs, pipes, and valves.

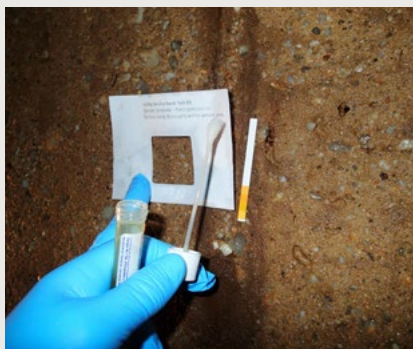
IMAGE 4: SURFACE TESTING

Sample collection on coupon surfaces was accomplished using swabbing techniques. Starplex's Starswab II swab devices were used for all testing. The Starswab II bacteriology culture collection and transport devices were specifically chosen for their consistency and reliability in in vitro diagnostic uses and compatibility with a wide range of bacteria. A standardized template (13.69 cm<sup>2</sup> or 21/8 inch<sup>2</sup>) was used in order to ensure a consistent sample area was maintained during all sampling events.

All sampling was conducted on vertical coupon surfaces. Once collected, swabs were processed using a proprietary method developed in house designed specifically for extracting and testing the common waterborne contaminants found in potable water systems. Each swab was thoroughly rinsed with ATP free water and placed in a vortex centrifuge for 30 seconds to extract biological and mineral contaminants. This process was repeated in triplicate for each sample to ensure good extraction from the swab device. The extracted contents were then suspended in a sterilized, non-nutritional, buffered solution compatible with rapid screening methods. All testing was accomplished within 4 hours of the sample collection.
